TEST REPORT
IMPACT TEST OF EXEL APPROACH LIGHT MASTS

Juhani Hanka
Markku Vahteri

OCTOBER 1991

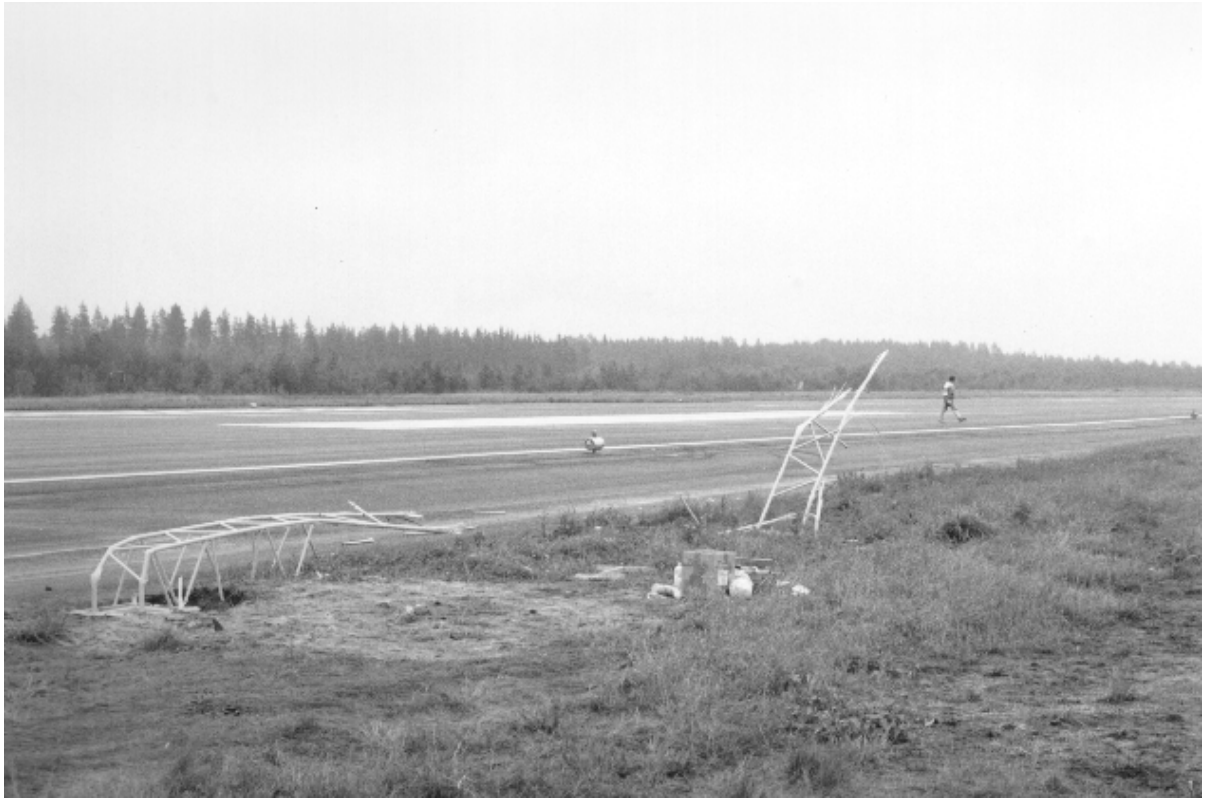
Figure 11 Remains of the mast 2 after the test.

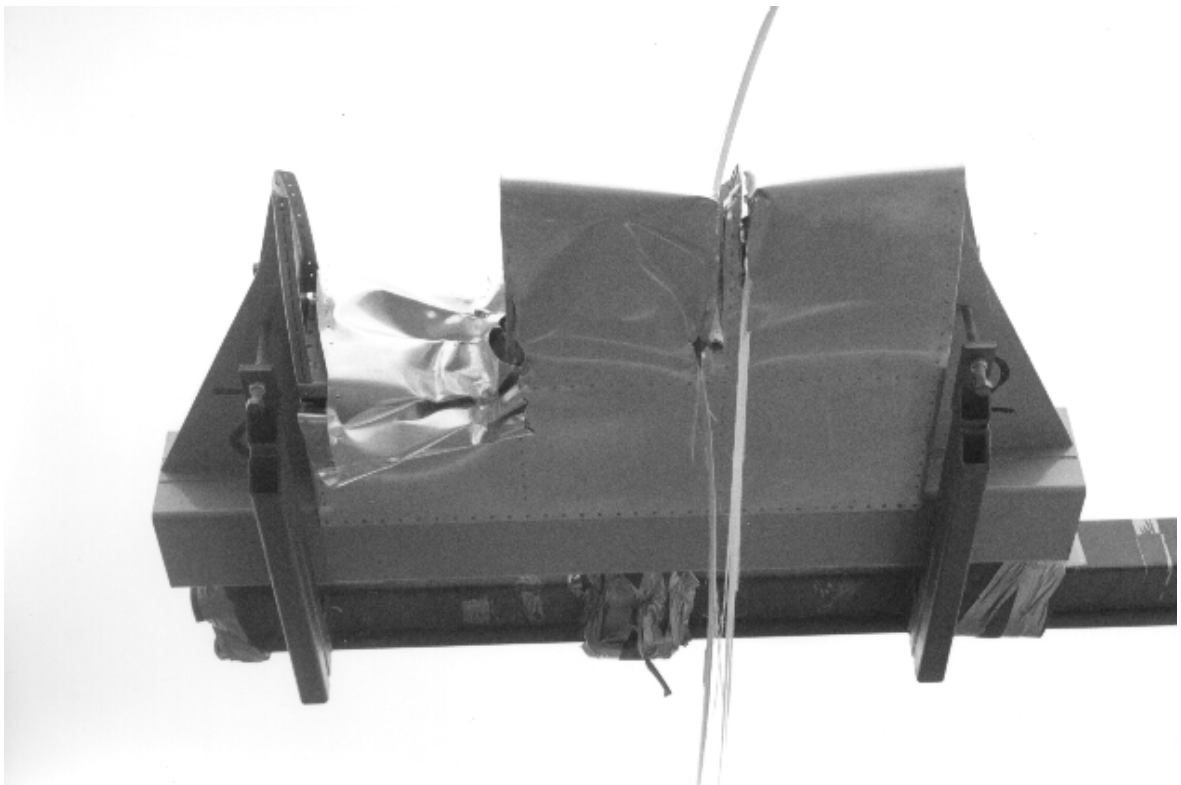
Figure 12 Damaged wing section after the test 2. The leading edge skin panels were severely damaged but the inner load carrying structure remained intact.

The most important result from these tests in general was the fact that the tested masts did not break the wing structure. At the first sight the damages suffered by the wing section appeared to be quite severe. Closer inspection soon revealed, however, that the wing load carrying structure -- the frame work of spars and ribs -- was not damaged at all. The aerodynamic shape of a narrow leading edge section was lost with the crushed leading edge panels. The torsional stiffness was also slightly reduced since this nose section forms a part of the wing torsion box. The effect of this reduction is minimal. What is more important, the capability of the structure to carry bending and shear loads was not affected at all.

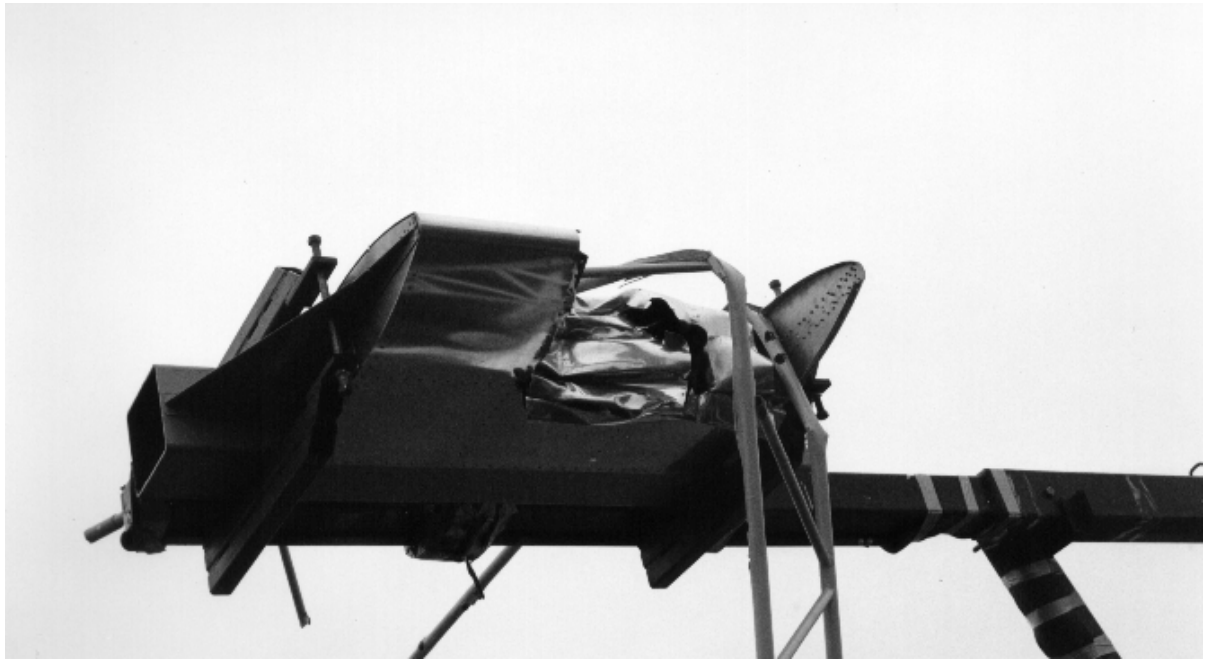
Another reason to the wrap-around was the composite structure itself. This was detected especially in test 1. Longitudinal splitting of the composite structure in the vertical tubes prevented the cut-through of the tubes at the opposite side of the impact. It has been assumed that a small change in the tube structure would turn the crack growth in the tube wall partly in transverse direction, thus helping the vertical tubes to cut apart more easily, in case of a sudden impact.

Figure A1.3 Test wing section immediately after the impact. Part of one side of the mast remained hanging from the wing. In this case it was completely loose, it did not get stuck. Note that the penetration has stopped at the front spar and that in the outmost rib section even the thin skin panels remain undamaged.

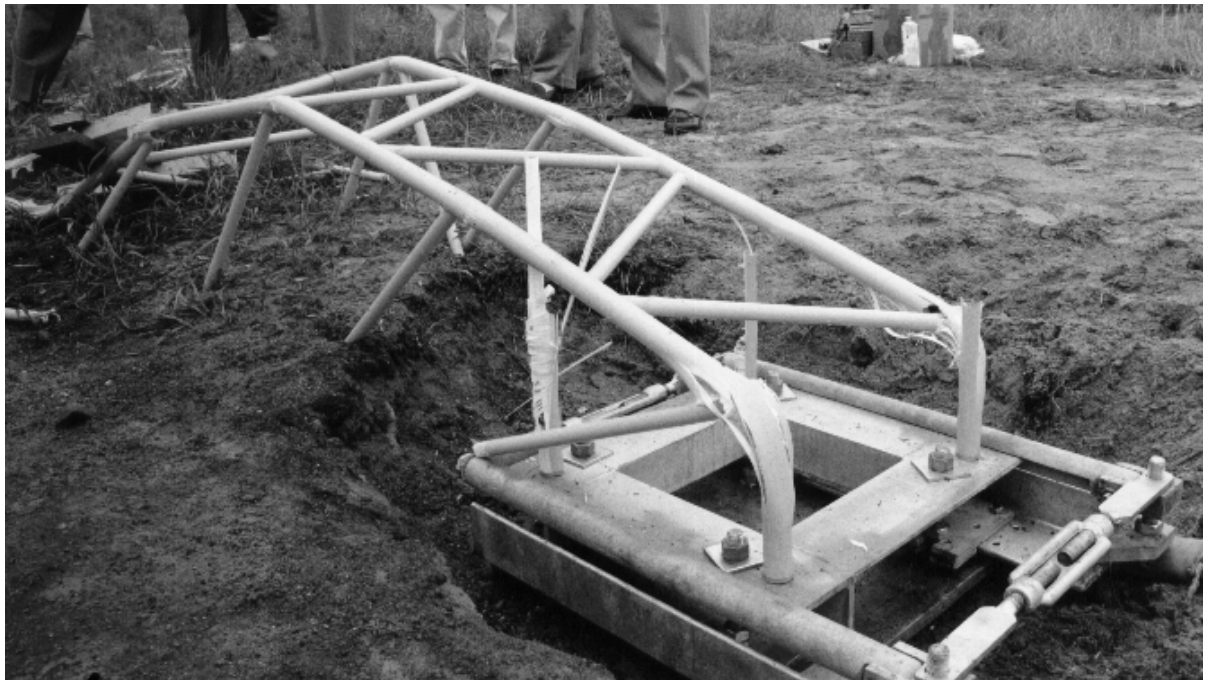
Figure A1.4 The lower section of the collapsed mast. The mast was cut in the middle at the impact side and almost at the base at the other side. It also broke into two parts longitudinally which can be seen also from the previous picture. Note the fallen weight in the upper left corner.

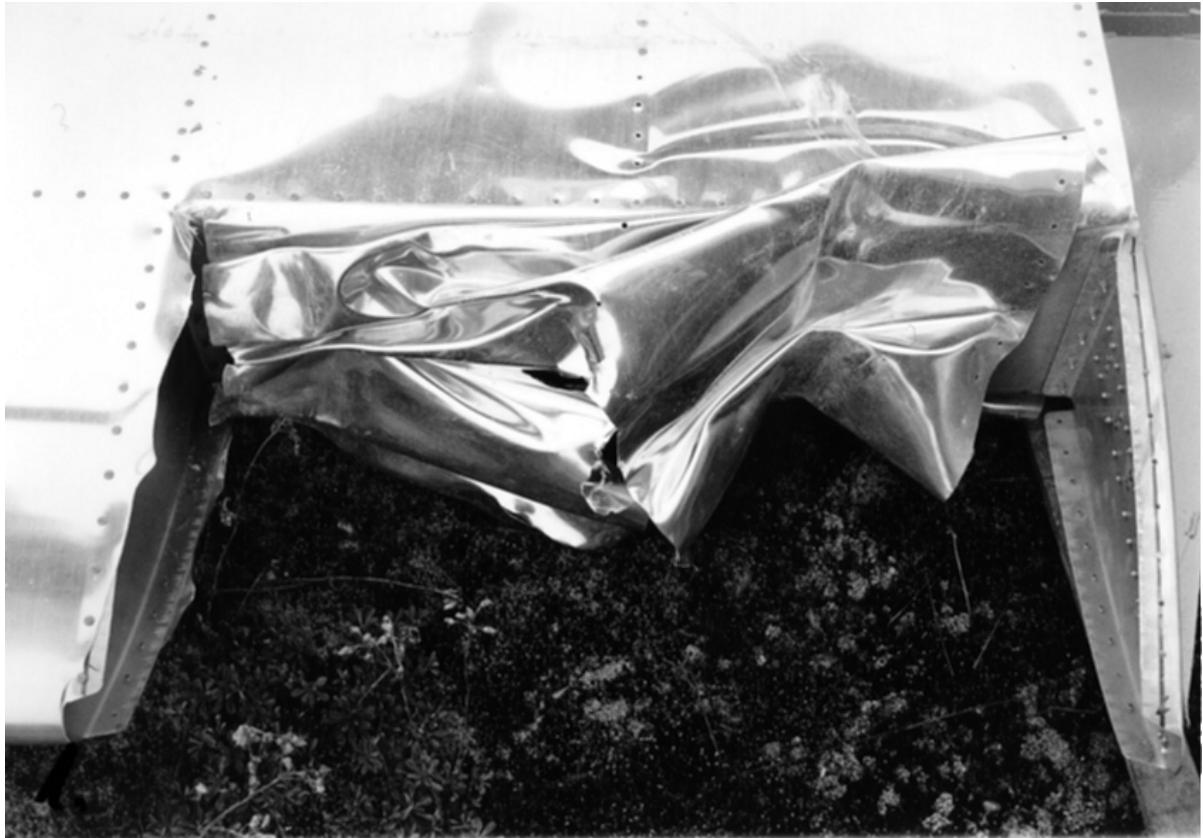
Figure A1.5 The damages caused to the wing are clearly visible in this picture. The 0.8 mm skin has been torn and crushed, but the front spar has not been touched. The only damages further back are the small buckle in the rightmost panel and three loose rivets (rib/skin joint in the middle).

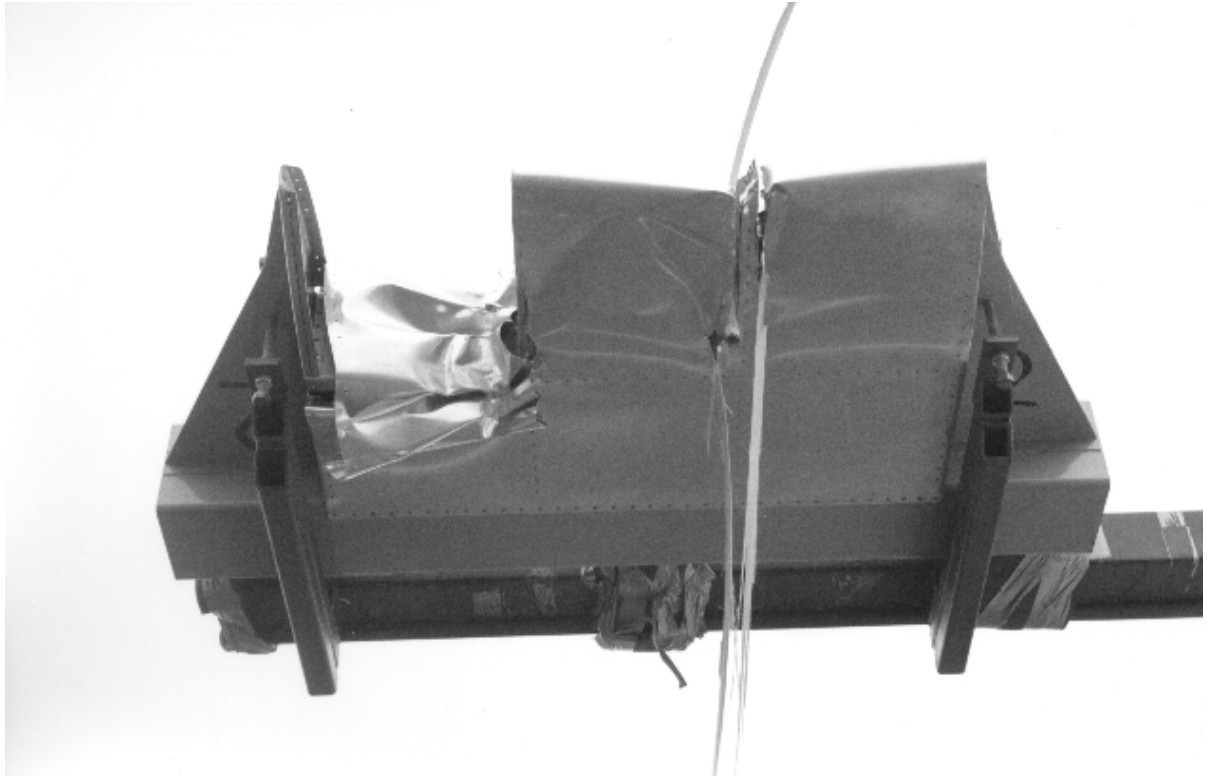
Figure A1.9 The outmost rib section was crushed as in test 1, but a few rivets from the skin/front spar joint were cut. Also the other two rib sections were torn apart from the ribs by long split fibres of the "rear" (=opposite side to the impact) vertical mast tubes. This was the only test when this occurred.

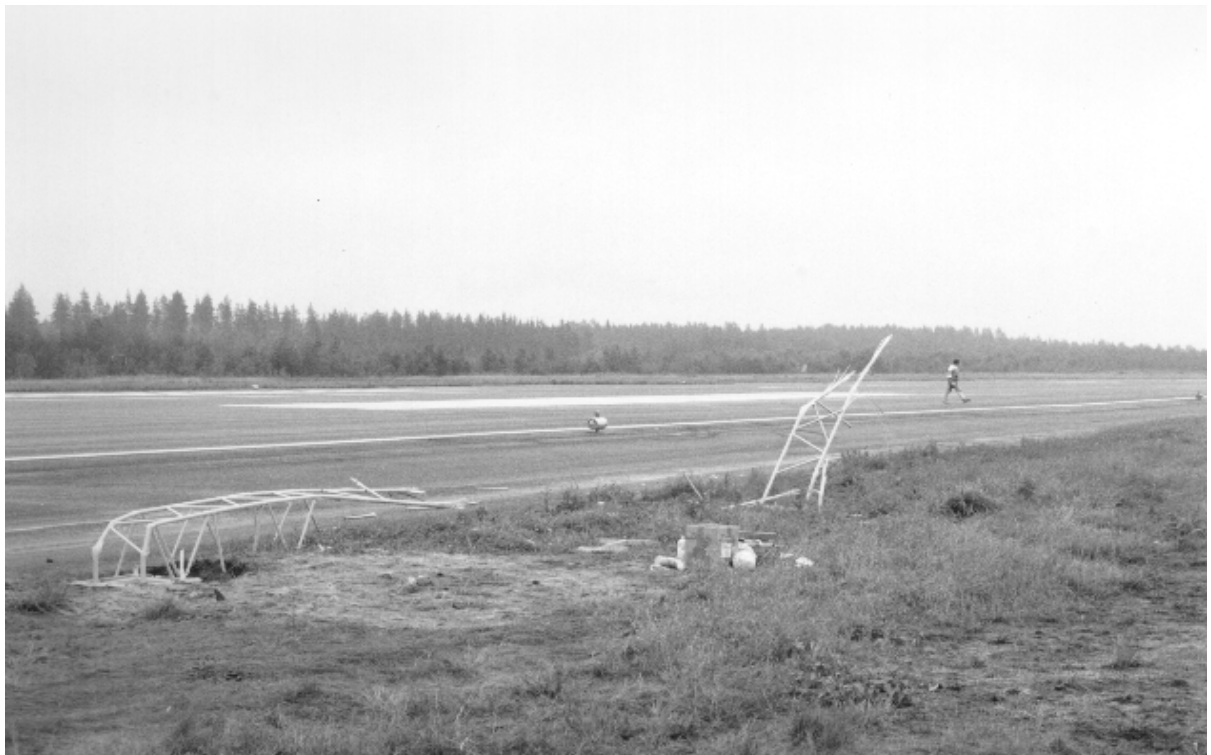
Figure A1.10 The mast broke into two main sections and into numerous separate parts.

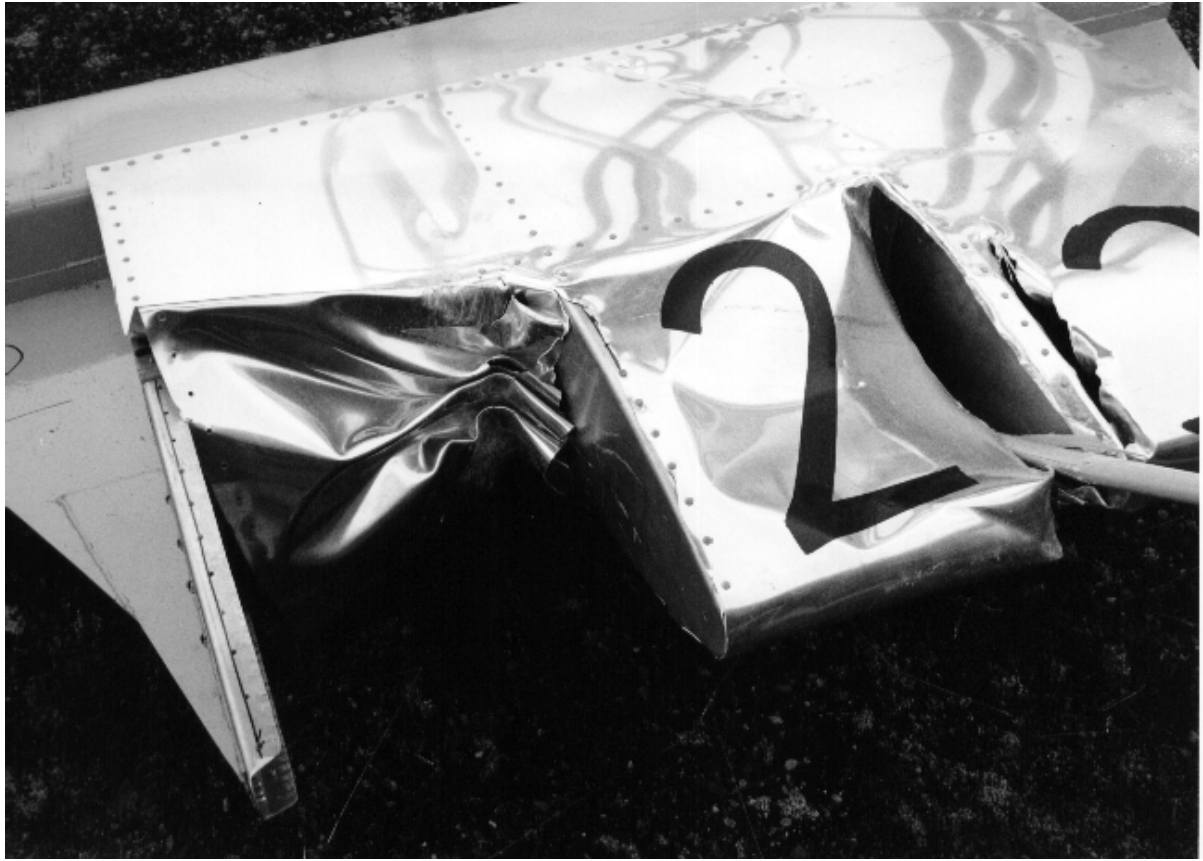
Figure A1.11 The unique failure mode of this test is clearly visible. The front spar was not damaged despite the cut rivets.

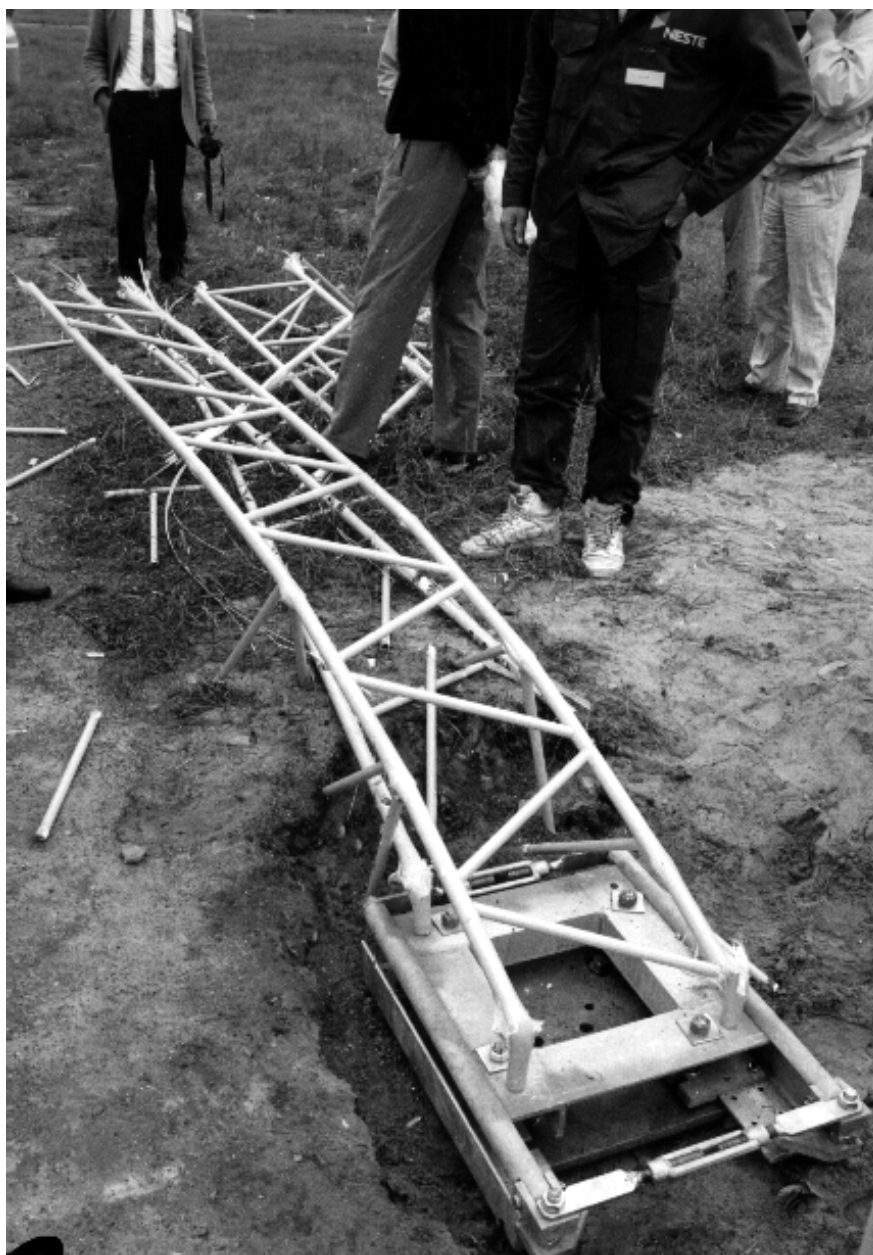
Figure A1.14 The mast was cut through by the impactor. The upper part broke into several parts and the lower section suffered a total collapse when the vertical tubes were bent at the root and most of the diagonals came loose. This is a very good example of the frangible behaviour of the masts.

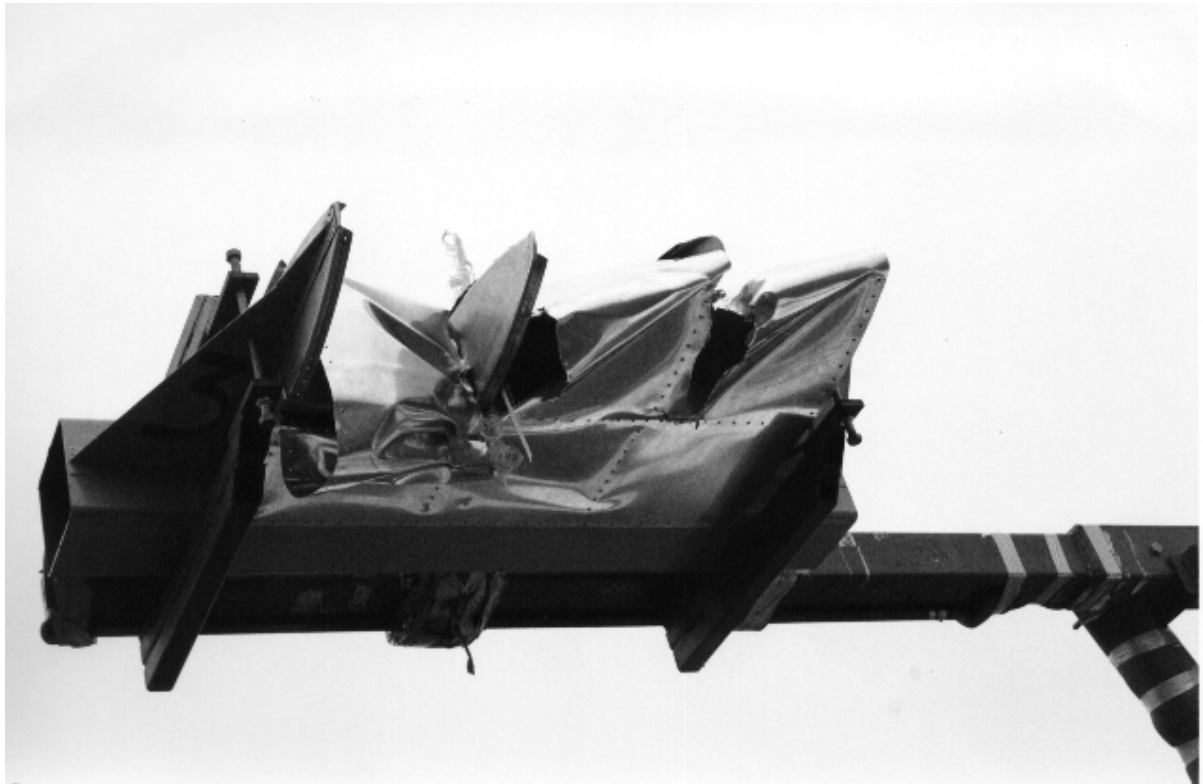
Figure A1.15 The 400 mm wide mast hit the wing section with 300 mm rib spacing so, that the verticals met the leading edge just on the outer sides of the ribs in the middle. Due to this, all the three leading edge panels were damaged when the diagonals hit the rib section in the middle. Again the damages were limited to the area in front of the front spar.

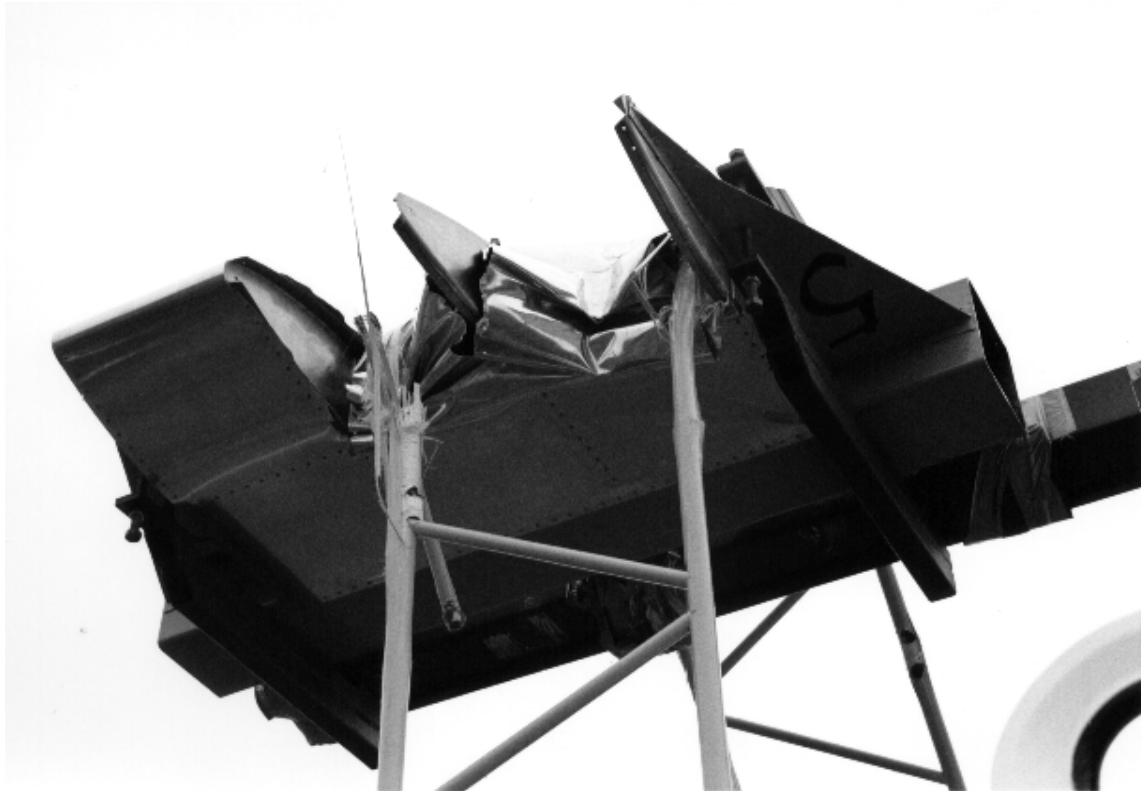
Figure A1.18 Mast 5 was the first one with cables. The mast showed a tendency to wrap around because neither of the rear verticals was cut by the impactor.

It can be concluded that the wrapping tendency that occurred especially with the masts with cables, was not critical but should be removed. Partly the wrapping was caused by the cables (and the cover tube) which did not always break as wanted. This can be avoided with additional connection points in the cable.

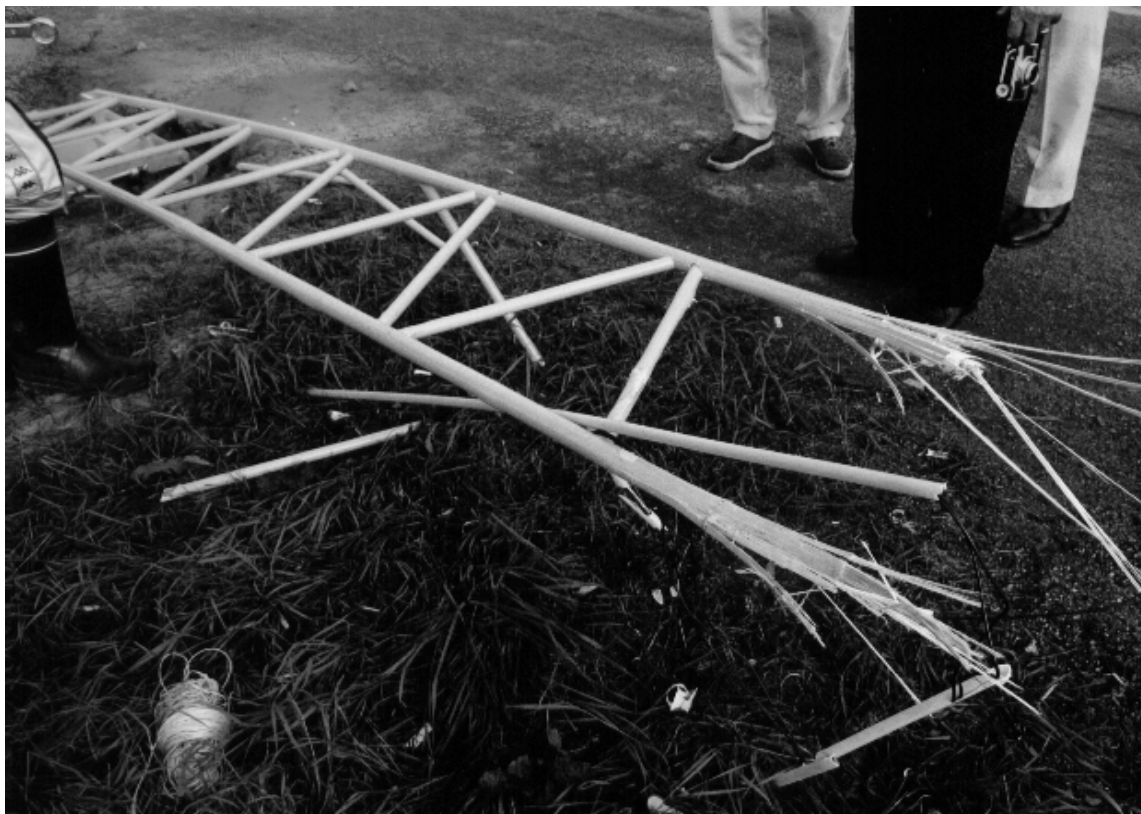
Figure A1.19 The cables and the cover tubes were cut by the impactor as can be seen.

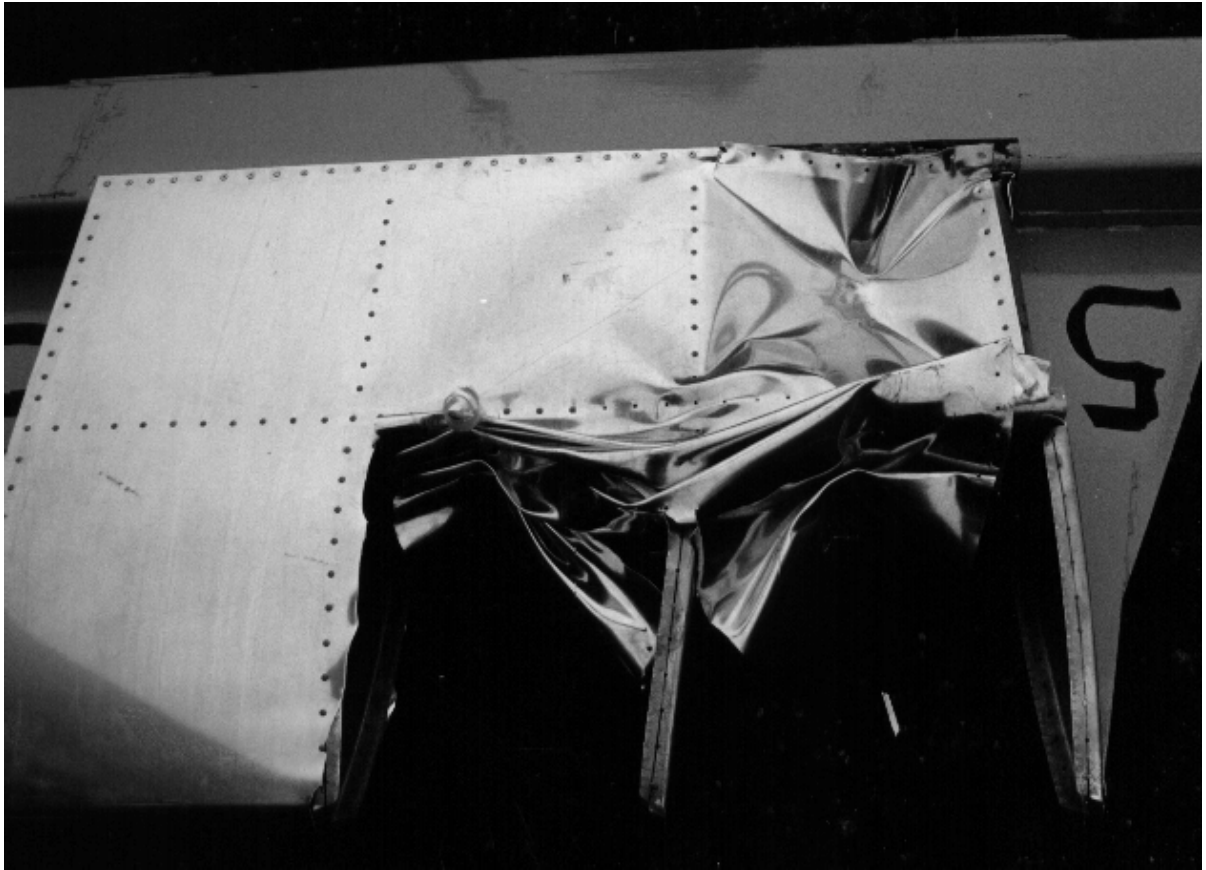
Figure A1.20 Damages were very similar to test 1 except a slight bending of the rib and the deformation in the upper right corner. The latter was caused by a single diagonal that was still attached to the vertical tube when it bent over the wing.

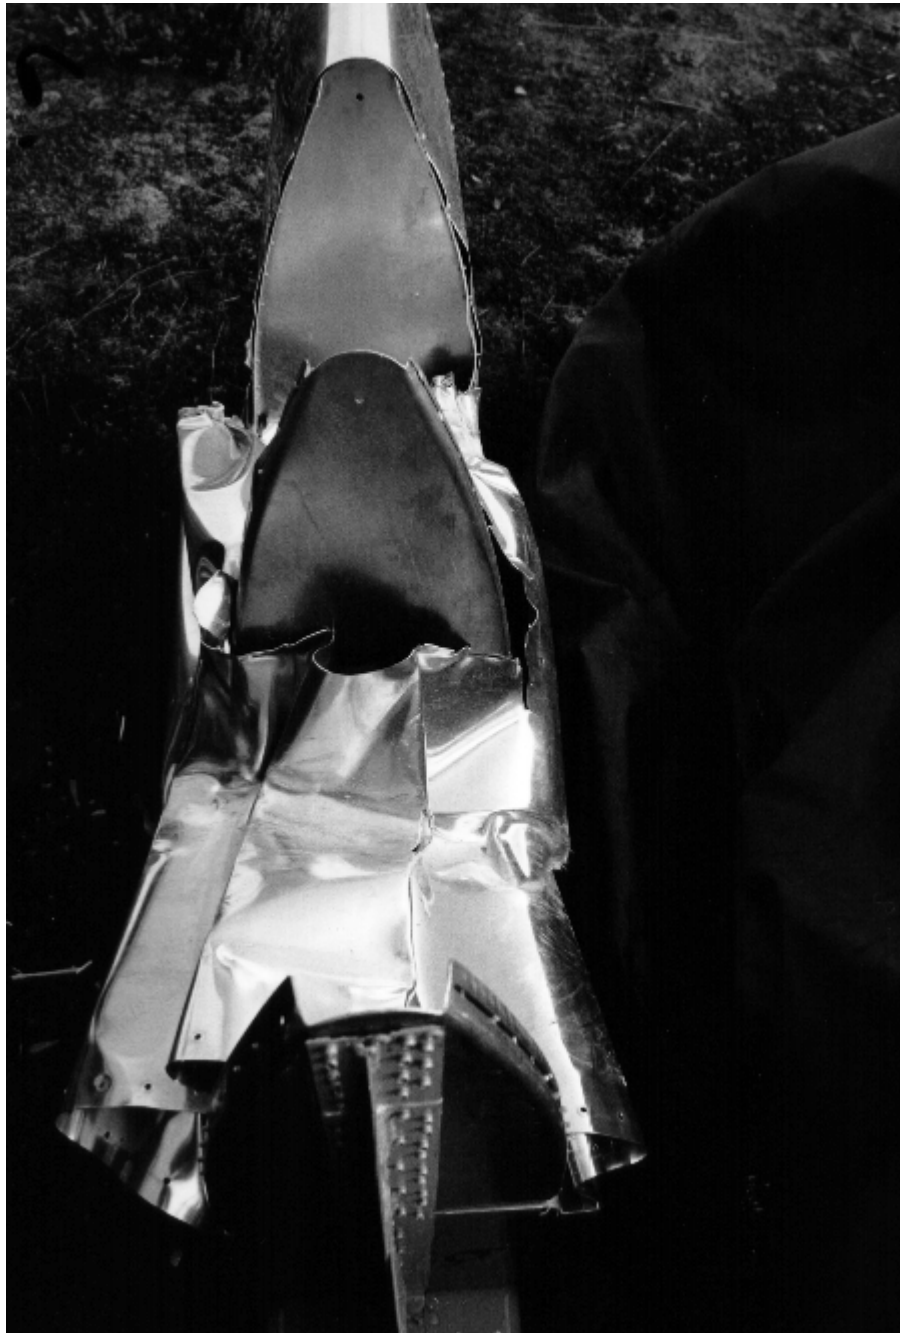
Figure A1.23 Side view of the damaged wing. Damages are very similar to those of tests 1 and 5. The behaviour of the mast was almost identical to the test 5 (not shown).

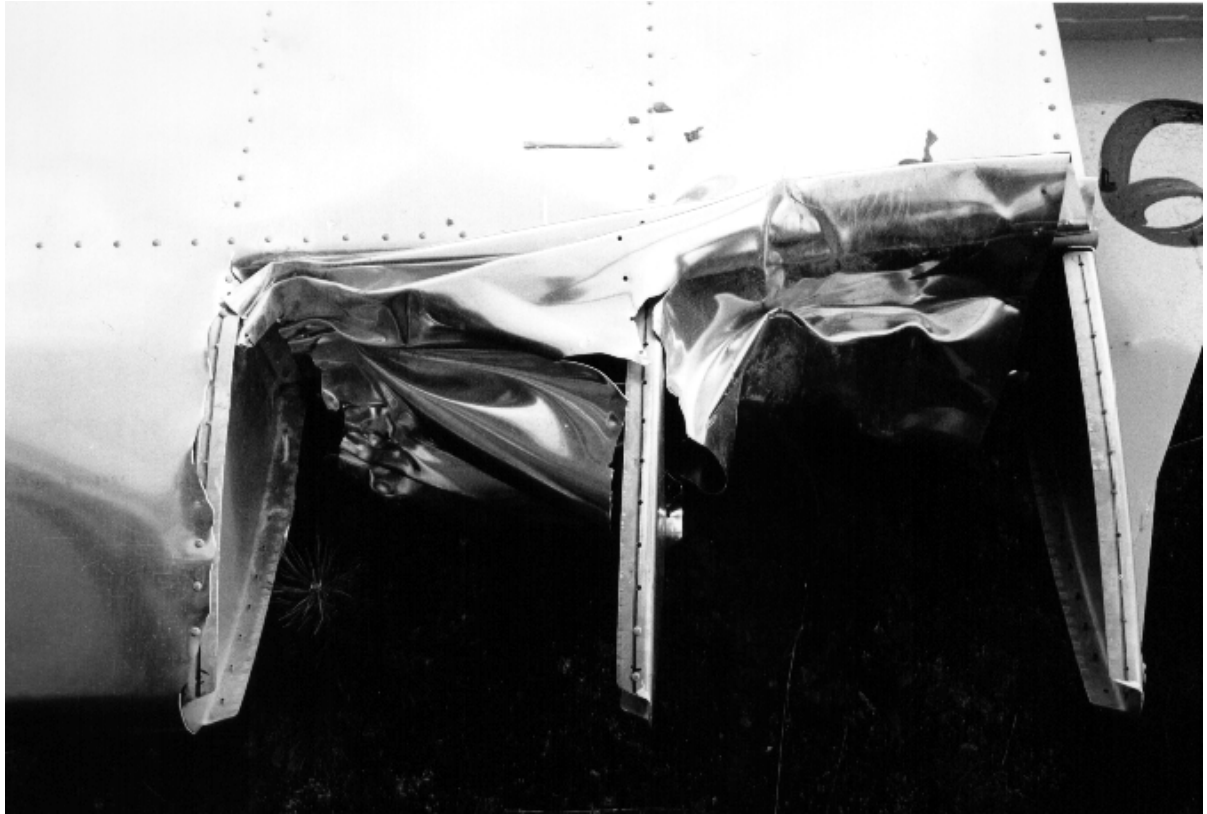
Figure A1.24 As seen already from the previous picture this a very typical example of the wing section of these tests: two crushed leading edge sections, the next rib section in perfect condition and the front spar intact. It is obvious that an aircraft with this kind of damage would still be able to fly. The fact that this wing section suffered the highest impact energy, could not be detected in the post-impact inspection.

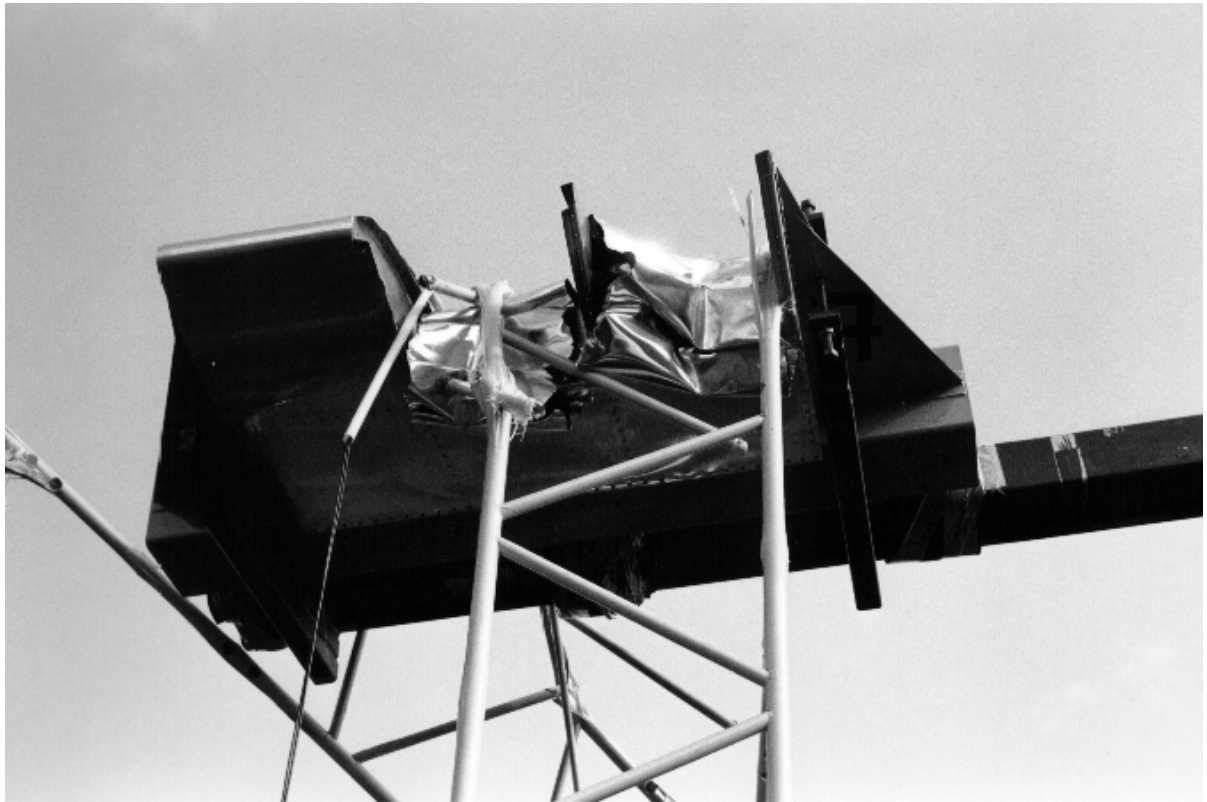
Figure A1.27 In test 7 the mast structure acted like in tests 5 and 6 but the cables and the cover tube failed to cut. In this test they were located at the side of the impact. From the high speed camera recording it can be seen that this is also the side of compressive loading, which is a possible reason to this cable behaviour. It can be seen that again it was the "rear" plane of the lattice structure that bent around the wing section.

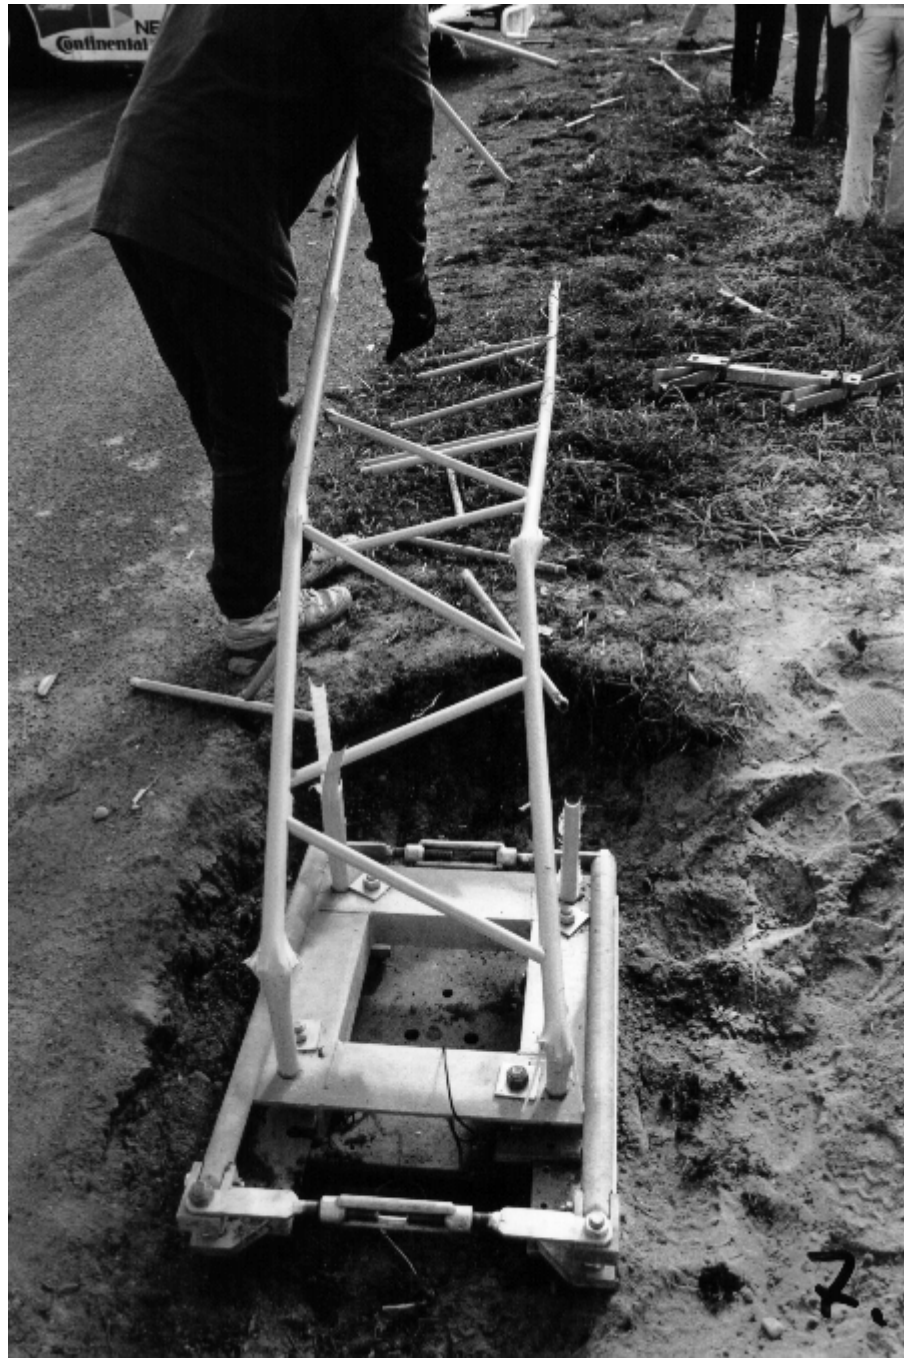
Figure A1.28 The lower section of the broken mast was left somewhat shorter in this test. The mast top weight is again visible in the upper right corner.
