LTR-SMPL-2009-0120

Date: 27-July-2009

For: Exel Composites Oyj
Pour: Muovilaaksontie 2
FI-82110 Heinävaara, Finland

**Frangibility Analysis of Approach Lighting Composite
Tower**

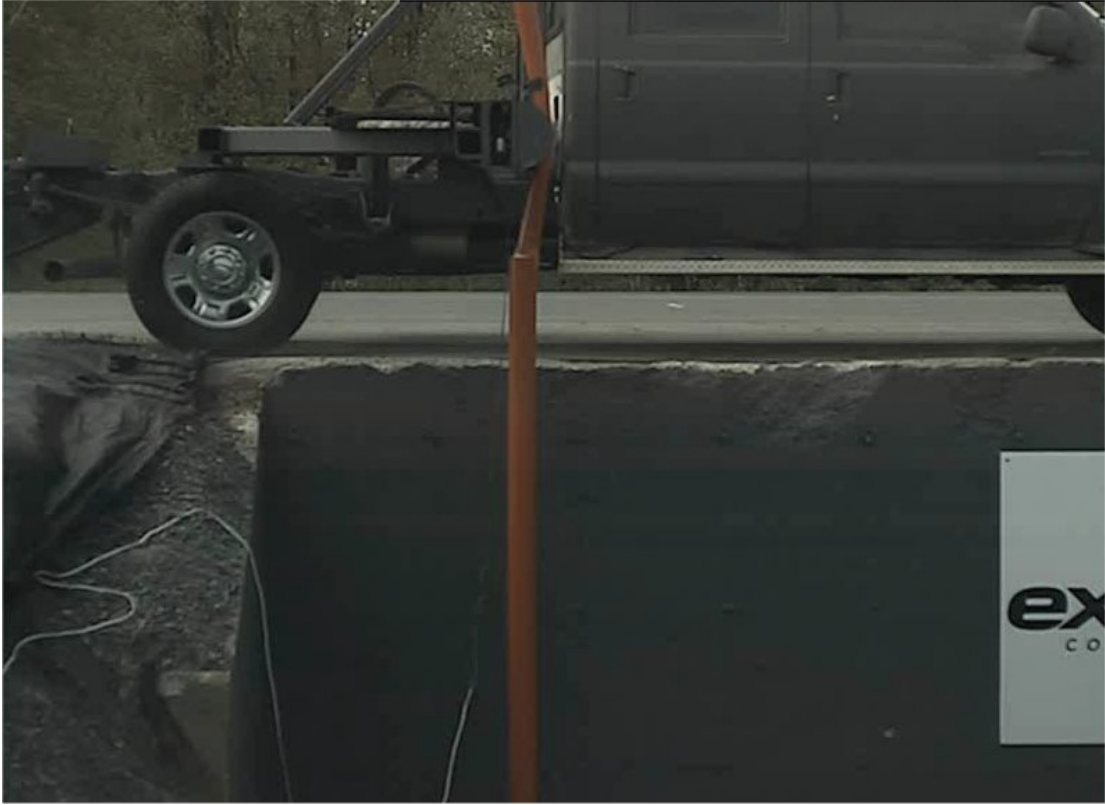
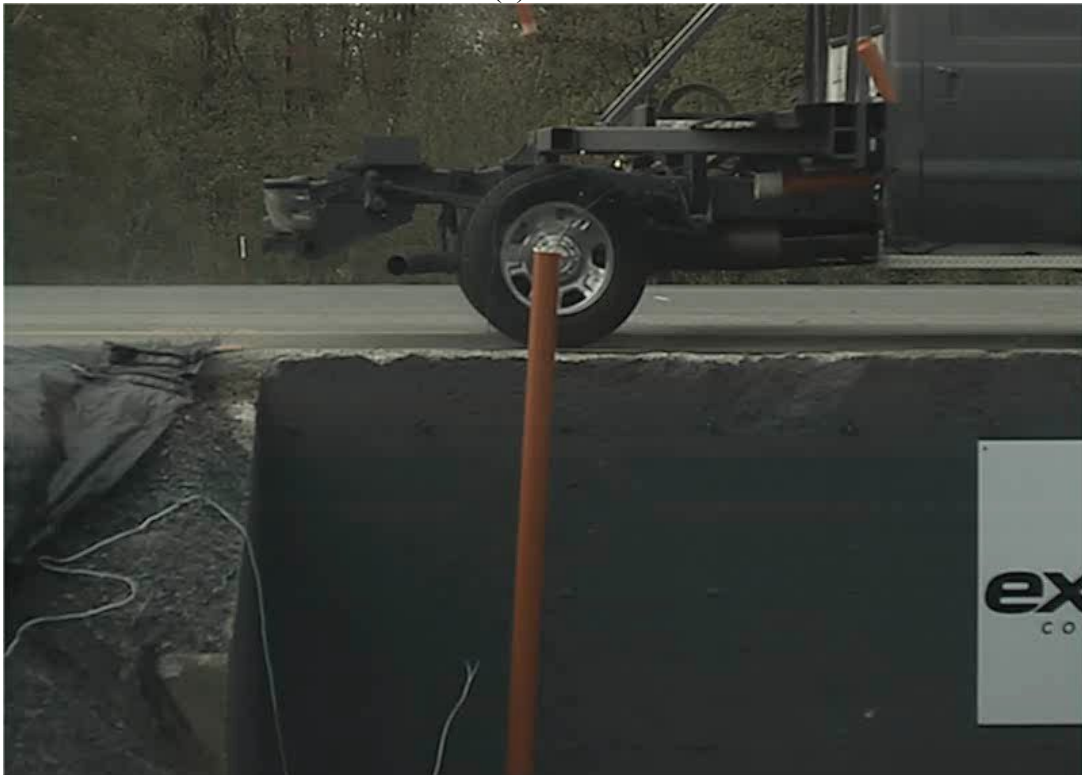
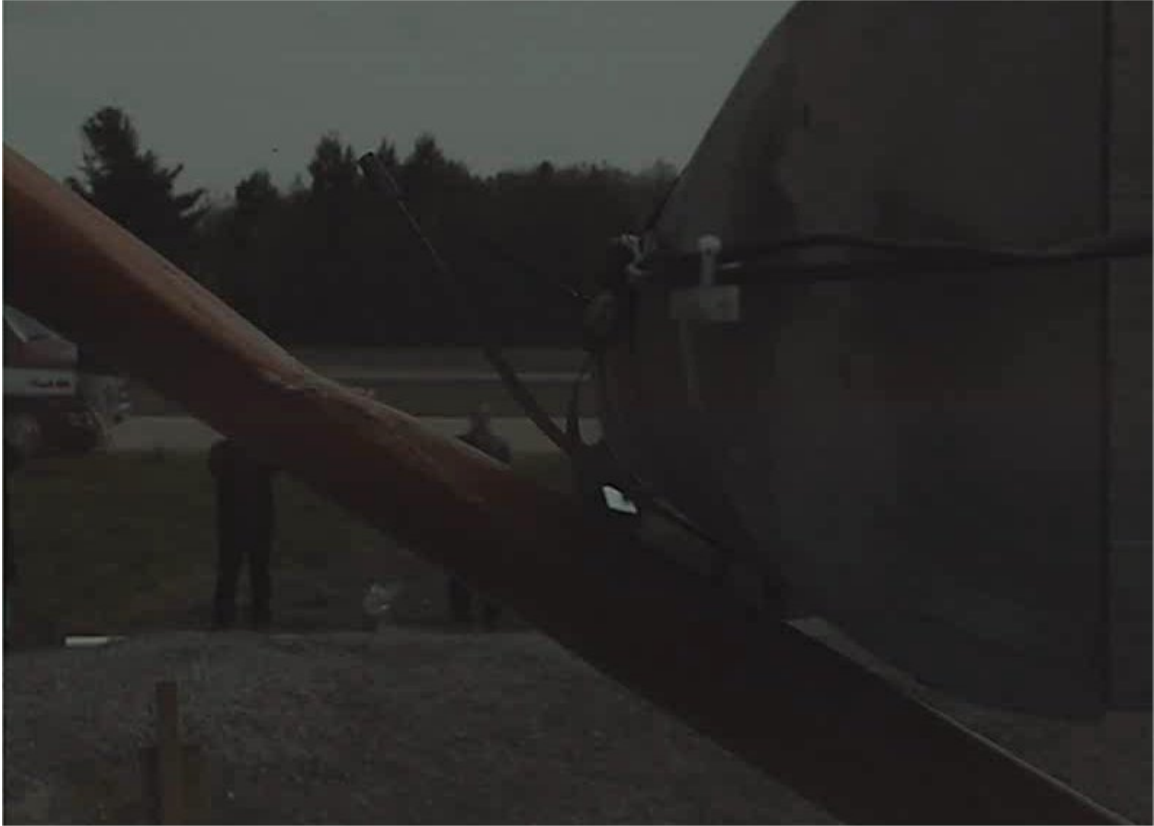
Figure 7: Impact events from full-scale test of D106 pole

Test image frames from the full-scale test for this impact case are shown in Fig. 7. The time resolution of the video image was 0.5 millisecond (ms). The test image frames showed that the top portion of the pole separated from the bottom portion. This top portion wrapped around the impactor for the first 82 ms and was then dropped. A failure mode of fracturing combined with bending was observed. The average time to failure was 3 ms. It should be noted that the energy to failure was not as significant as the energy transferred during the contact period. After failure, the pole remained in contact with the

impactor for 82 ms and energy was still being transferred to the impactor. In addition; the electrical cabling separated and did not impede the fracturing or bending of the structure. The impactor did not become entangled with cabling.

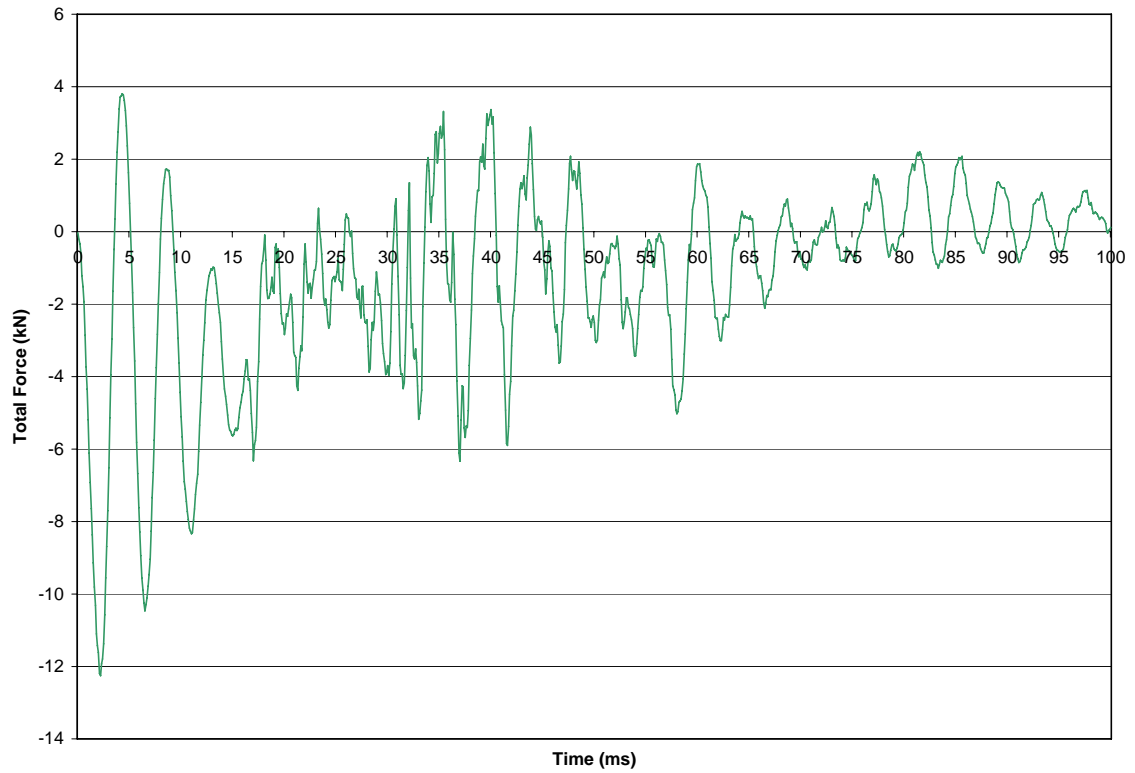
Figure 8: Impact force over time from full-scale test of D106 pole

The magnitude of the impact force versus time is represented in Fig. 8. It can be observed that the first maximum load represented the first peak load (12.3 kN) experienced by the pole, occurred during the first 4 ms after impact. It is believed that the oscillations in the full-scale test impact force-time curve were a result of vibration in the impactor and/or impactor support structure.

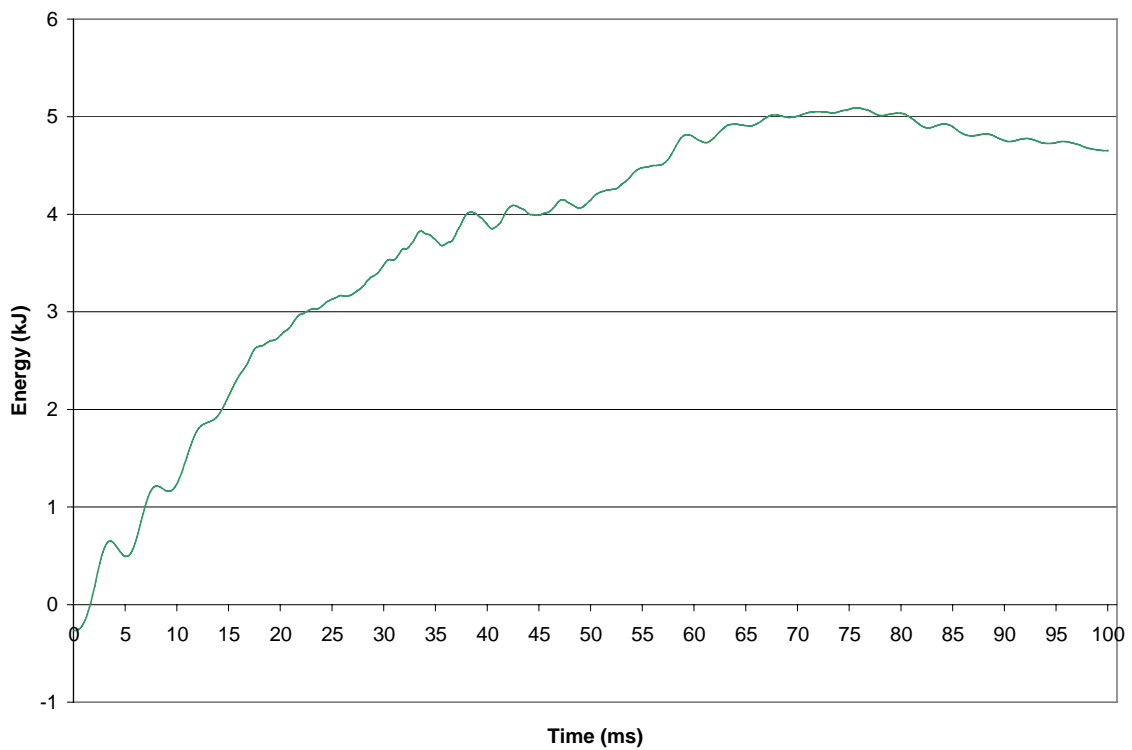
Figure 9: Energy absorption over time from full-scale test of D106 pole

The energy absorption curve versus time obtained from the full-scale test is shown in Fig 9. Kinetic energy was imparted to the pole during the contact period between the pole and impactor and remained with the pole throughout the impact. The maximum final energy level was 5.3 kJ. It would appear that the calculated values for energy approached a maximum value asymptotically.

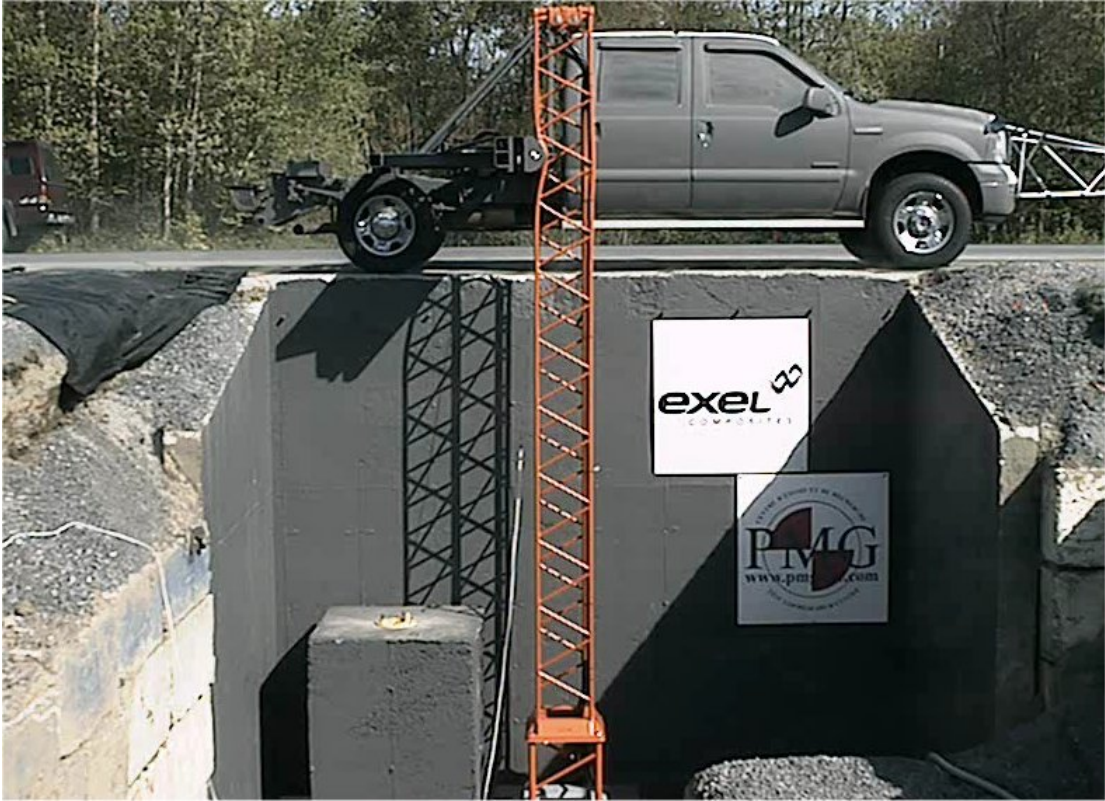
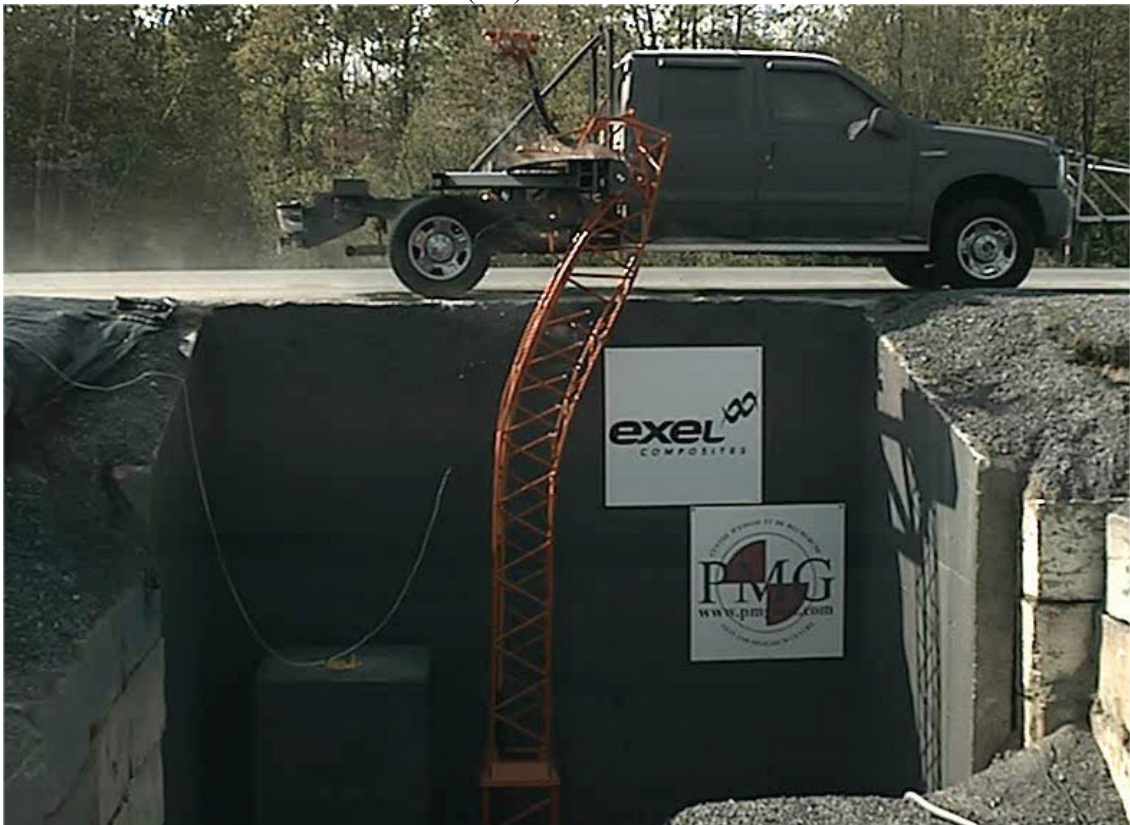
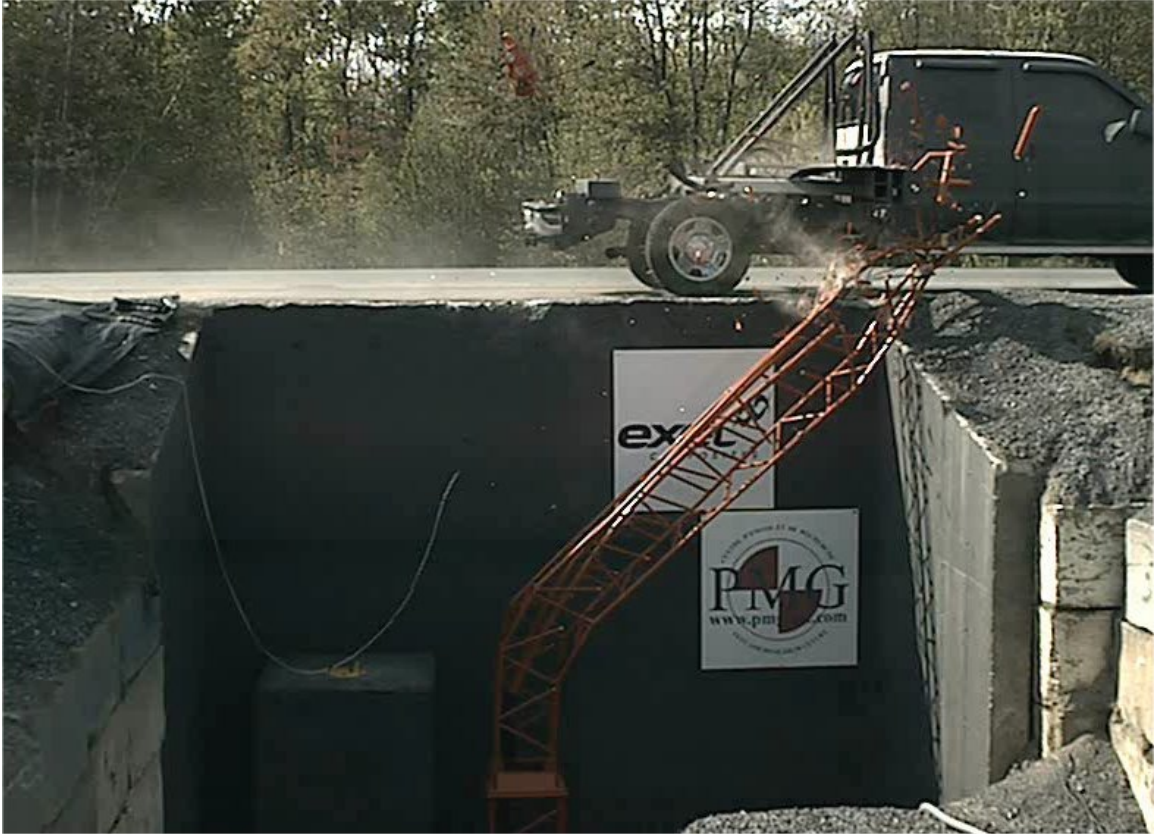
Figure 11: Impact events from full-scale test of L500 lattice tower

Test image frames from the full-scale test for the impact scenarios (a) and (b) are shown in Fig. 11.a-b, respectively. The time resolution of the video image was 0.5 millisecond (ms). The average time to failure was approximately 2 ms. The test image frames showed that the tower wrapped around the impactor for approximately 25 ms. Then the tower shattered into many lightweight pieces. It should be noted that the energy to failure was not as significant as the energy transferred during the contact period. After failure, the tower remained in contact with the impactor for 78 ms for scenario (a) and energy was still being transferred to the impactor.

In addition; electrical cabling separated and did not impede the failure or bending of the tower.

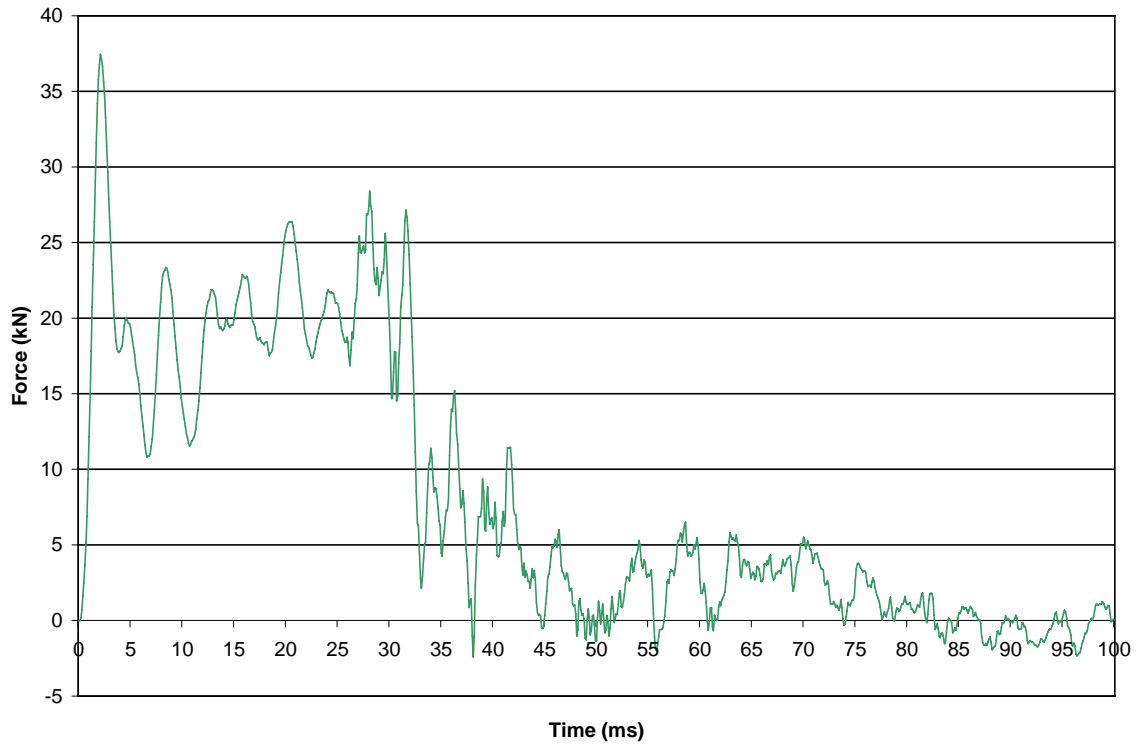
(a) Electrical cables run on impactor side

The magnitude of the impact force versus time for two scenarios (a) and (b) are shown in Fig. 12.a-b, respectively. It can be observed that the first maximum load represented the first peak load (37.4 and 36.0 kN for scenario (a) and (b), respectively) experienced by the tower occurred during the first 4 ms after impact. It is believed that the oscillations in the full-scale test impact force-time curve were a result of vibration in the impactor and/or impactor support structure.

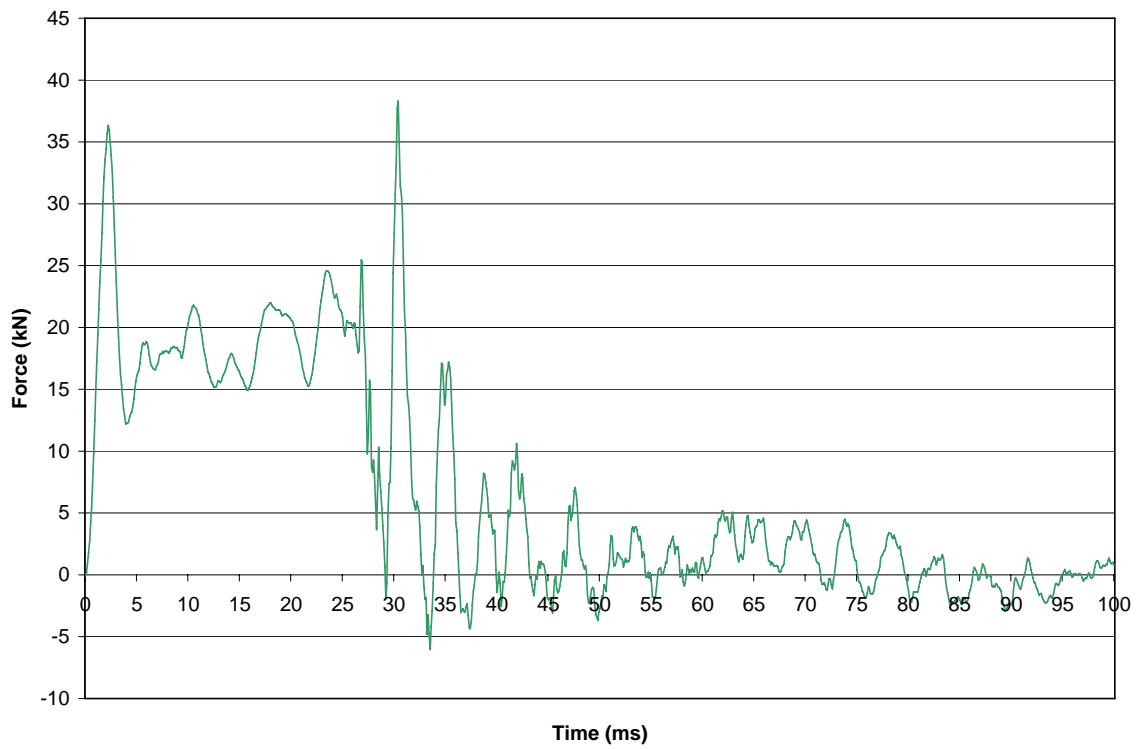
(b) Electrical cables run opposite to impactor side

Fig. 12b showed two peaks that were significant both in terms of their magnitude and the time at which they occurred. The first of these peaks occurred during the first 4 ms after impact with a magnitude of 36.0 kN. The second peak occurred during the latter stage of the impact after 30 ms with a magnitude of 38.3 kN. This second peak may be attributed to the electrical cabling position in scenario (b).

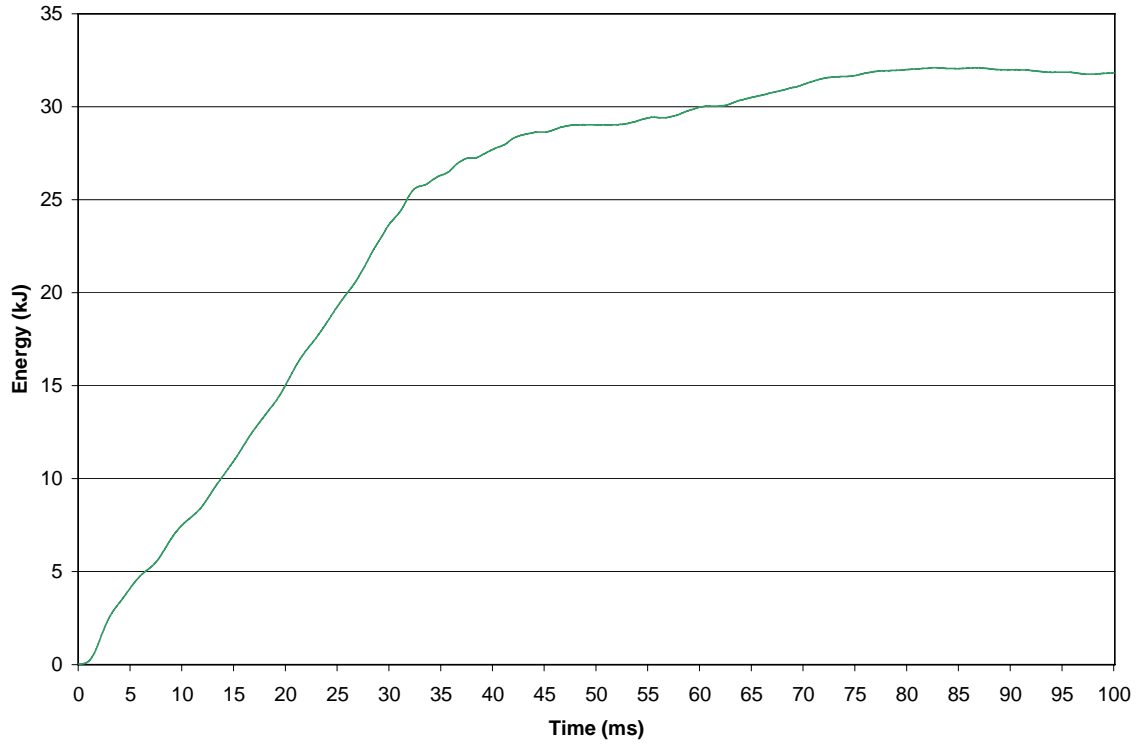
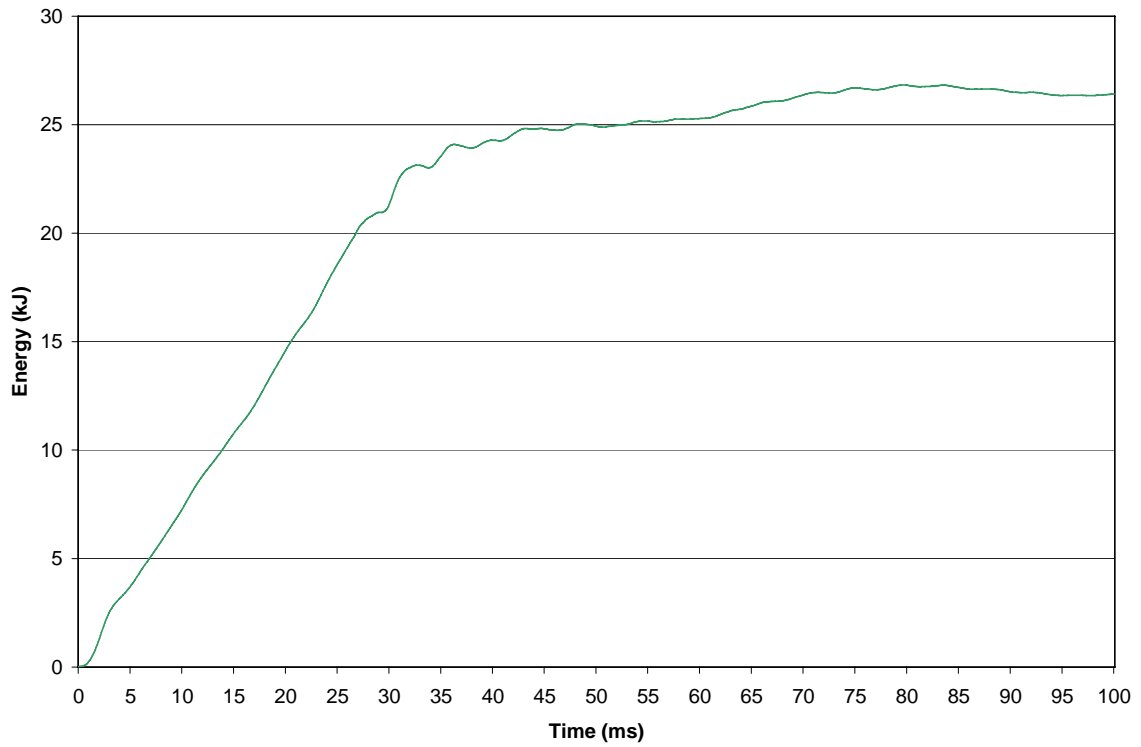
Figure 13: Energy absorption over time from full-scale test of L500 lattice tower

The energy absorption curve versus time obtained from full-scale test is shown in Fig 13.a-b. Kinetic energy was imparted to the pole during the contact period between the pole and impactor and remained with the pole throughout the impact. The maximum final energy level was 32.1 and 26.8 kJ. It would appear that the calculated values for energy approached a maximum value asymptotically.
